Project/File: Buchanan St. Joseph Riverfront Restoration Date: April 18, 2025

Reference: Buchanan St Joseph Riverfront Restoration - Proposed Trail Analysis

Field Visit September 2024 - Trail Photo Log Summary

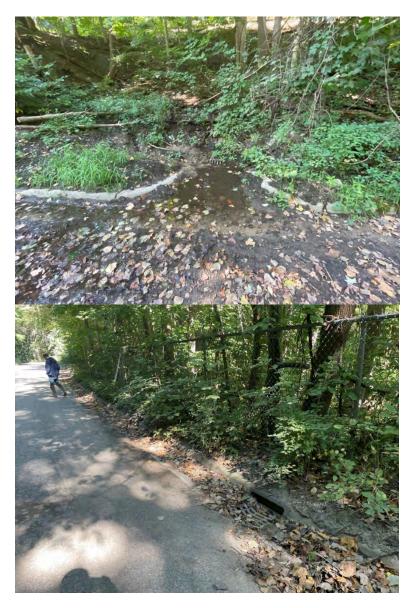
Photo 1: River Front Drive, facing stormwater inlet on south side of River Front Drive and base of slope from Red Bud Trail. This inlet ties to inlet on south side of River Front Drive below.

Photo 2: River Front Drive, facing west along north edge of River Front Drive at stormwater inlet (drains to Tributary 2).

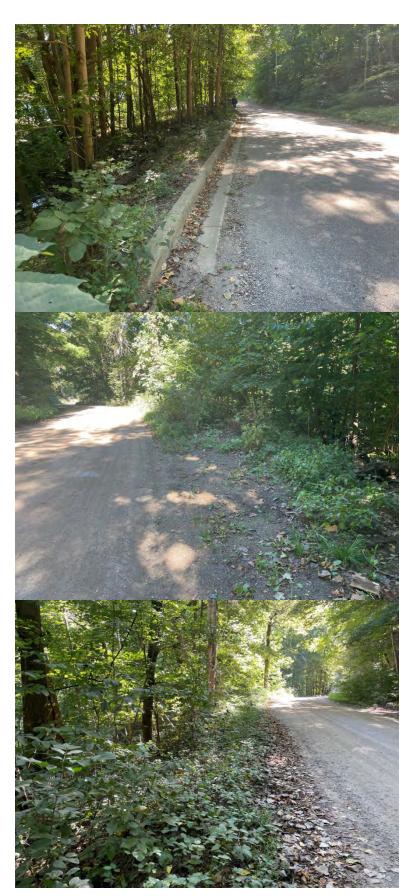
Photo 3: River Front Drive, facing east along River Front Drive toward Red Bud Trail adjacent to the private parcel. The Tributary 2 branch is on left.

Photo 4: River Front Drive, facing west along south side of River Front Drive at fill material encroaching into adjacent wetland.

Photo 5: River Front Drive, facing east along south side of River Front Drive.

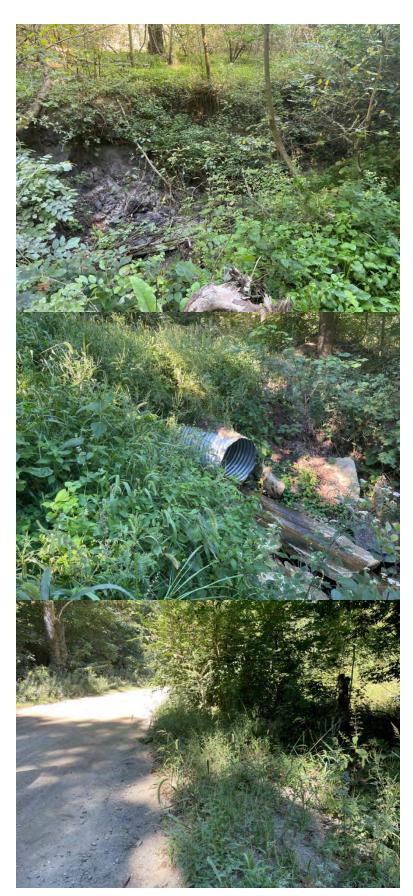
Photo 6: Facing north from River Front Drive at CMP outfall. Gully erosion issues were identified at this outfall to Tributary 2.

Photo 7: Second CMP outfall draining from north of River Front Drive into the wetland on the south side of the road.

Photo 8: River Front Drive, facing west along south side of access road. Fill encroachment into adjacent wetland was noted in the field.

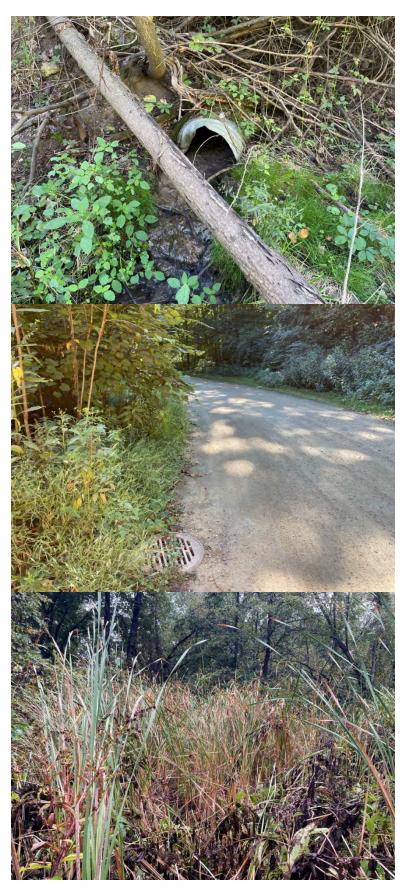
Photo 9: Third CMP outfall under River Front Drive draining from north slope of Red Bud Trail into the wetland on south side of the River Front Drive.

Photo 10: Stormwater inlet on River Front Drive draining to CMP outfall.

Photo 11: Cattail marsh at CMP outfall on south side of River Front Drive.

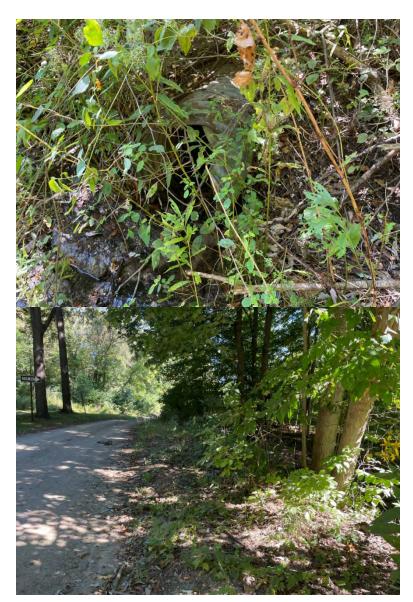
Photo 12: Fourth CMP outfall from River Front Drive into wetland on north side of road.

Photo 13: Facing northwest at the beginning of the divided entrance road from River Front Drive to the boat launch.

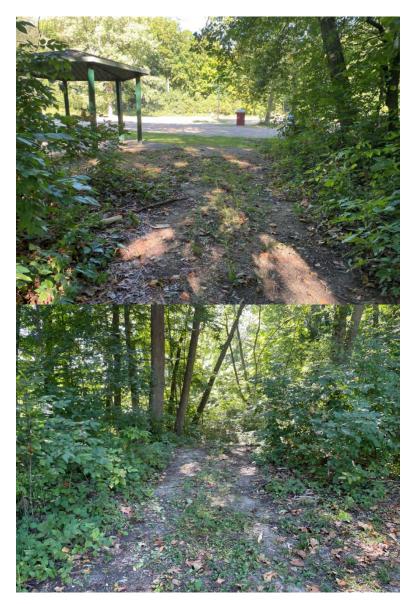
Photo 14: Start of existing trail, facing west into boat launch parking area.

Photo 15: Start of existing trail, facing east from parking area.

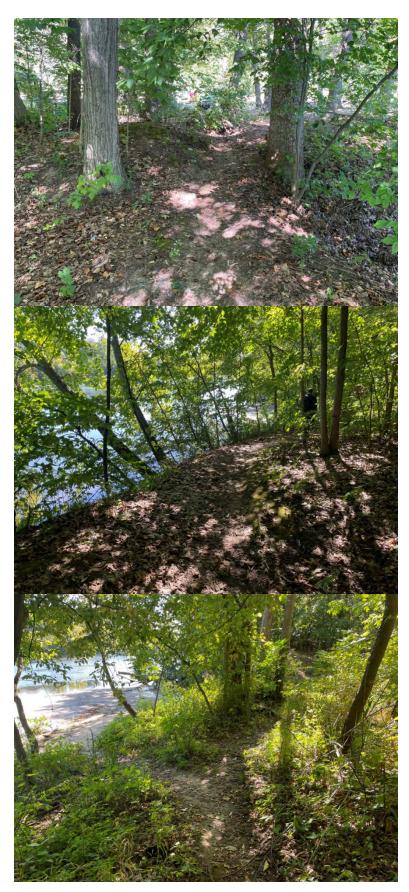
Photo 16: Facing west along the existing trail from approximately 100 feet beyond the parking area.

Photo 17: Facing east along the existing trail from approximately 100 feet beyond the parking area.

Photo 18: Facing east approximately 50 feet west of the Tributary 2 outlet to the St. Joseph River.

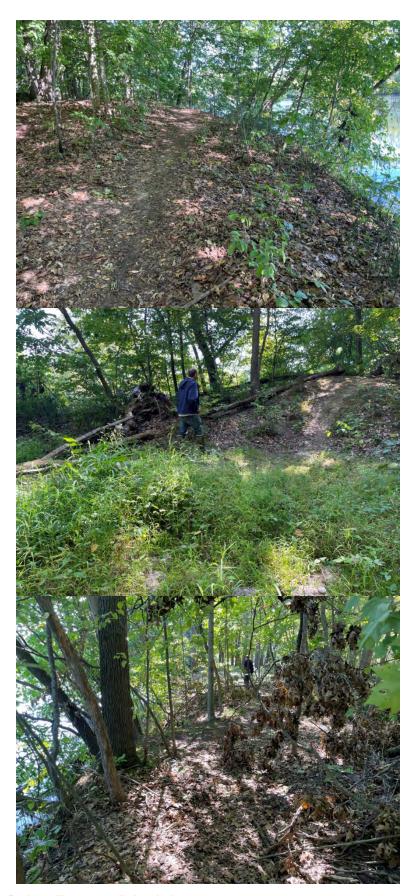
Photo 19: Facing west approximately 50 feet west of the Tributary 2 outlet to the St. Joseph River.

Photo 20: Facing east across the mouth of Tributary 2.

Photo 21: Facing east on the trail east of Tributary 2. East of Tributary 2, the trail follows an embankment along the St. Joseph River top of bank.

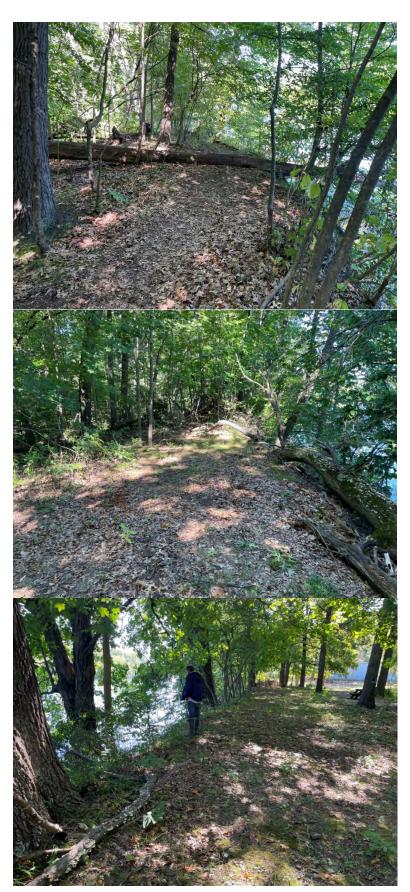
Photo 22: Facing west on the trail east of Tributary 2. East of Tributary 2, the trail follows an embankment along the St. Joseph River top of bank.

Photo 23: Facing west along trail and river embankment just west of maintained lawn area on the Library Services private property.

Photo 24: Facing east along riverbank into maintained lawn of Library Services private property.

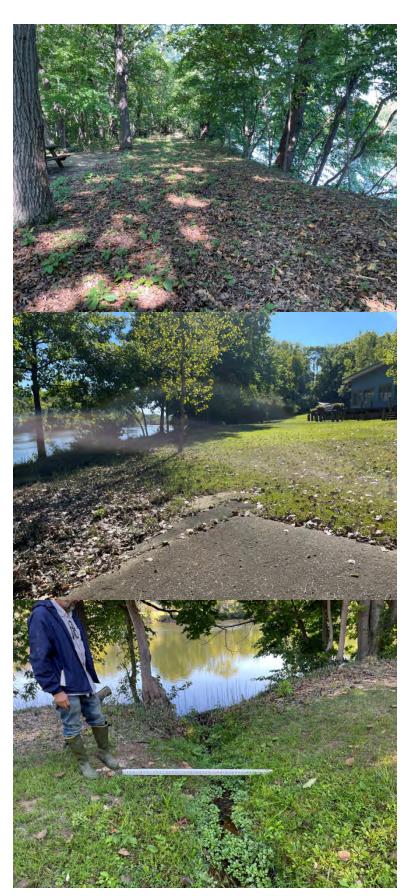
Photo 25: Facing west along riverbank from Library Services private property.

Photo 26: Facing east along riverbank from center of Library Services private property.

Photo 27: First waterway crossing on Library Services private property.

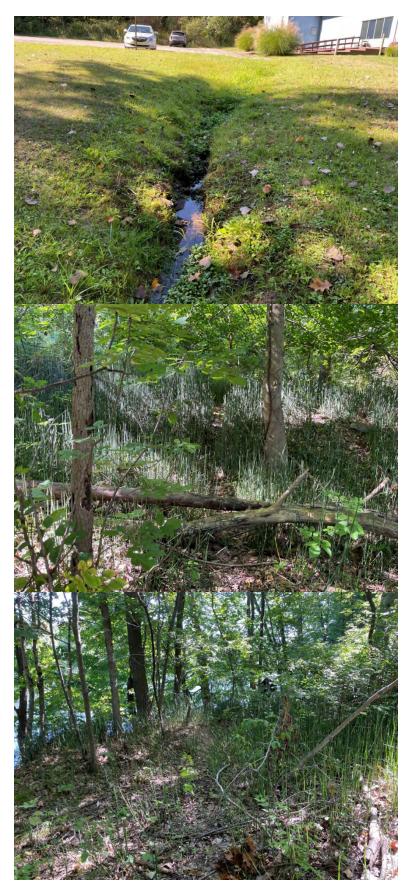
Photo 28: Facing south at waterway from parking area on Library Services private property.

Photo 29: Facing east at eastern portion of Library Services private property.

Photo 30: Facing east at woodland slope on eastern portion of Library Services private property.

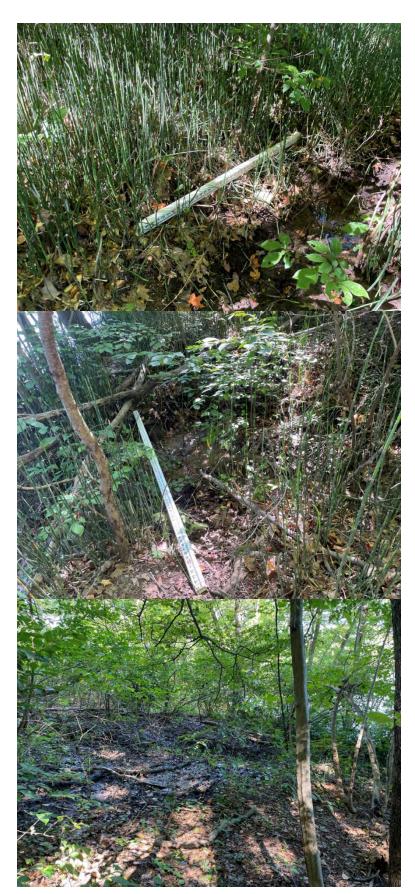
Photo 31: Second waterway/wetland on eastern edge of Library Services private property.

Photo 32: Third waterway/wetland drainage on east side of Library services private property.

Photo 33: Facing north at wetland seep area uphill from third waterway.

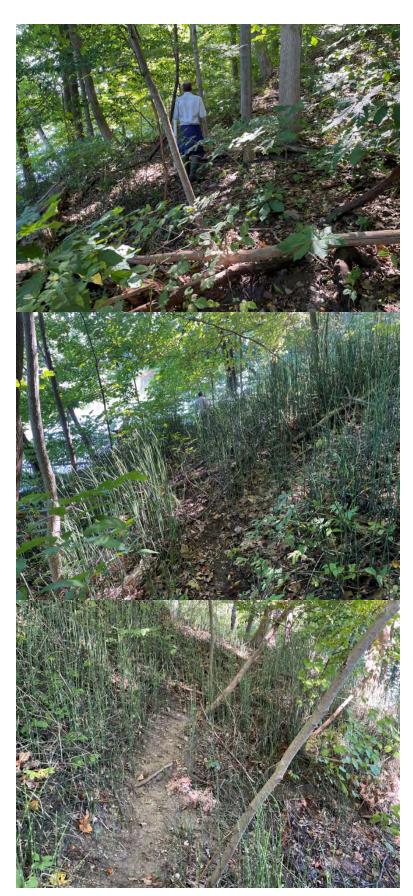
Photo 34: Facing east into East Park parcel noting steep slopes above top of riverbank.

Photo 35: Facing east along top of riverbank at potential trail location.

Photo 36: Facing west along top of riverbank showing steep slopes.

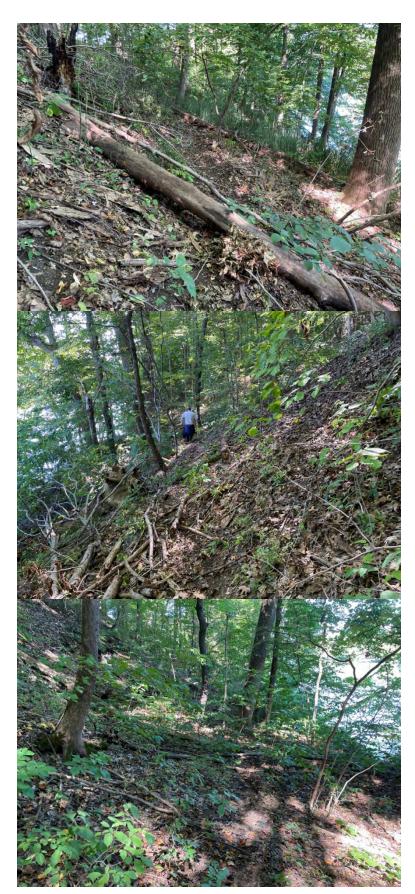
Photo 37: Facing northwest toward river showing steep bank.

Photo 38: Facing east along potential top of bank trail.

Photo 39: Facing west along potential top of bank trail.

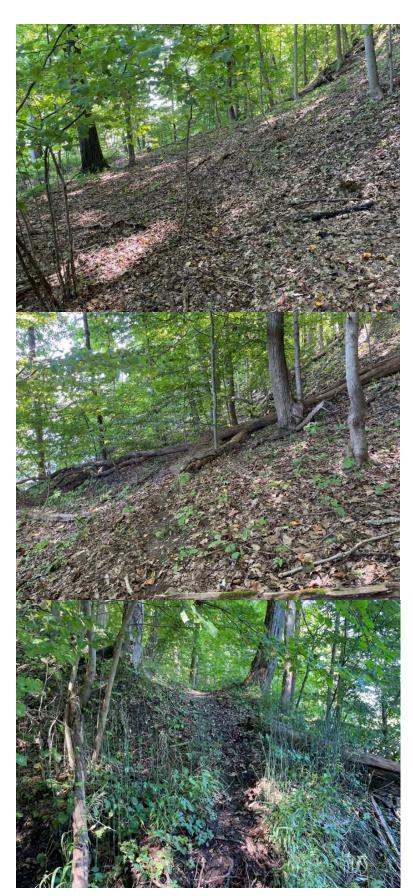
Photo 40: Facing east along potential top of bank trail.

Photo 41: Facing east along potential top of bank trail.

Photo 42: Facing south along existing lightly used trail to top of bank on steep slope.

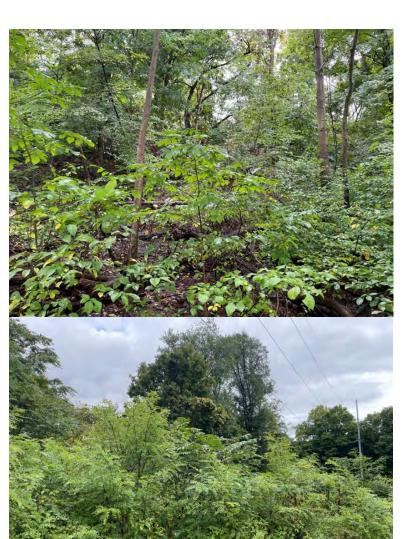
Photo 43: Facing south (uphill) along drainage near east end of park.

Photo 44: Facing east along top of bank at east end of park.

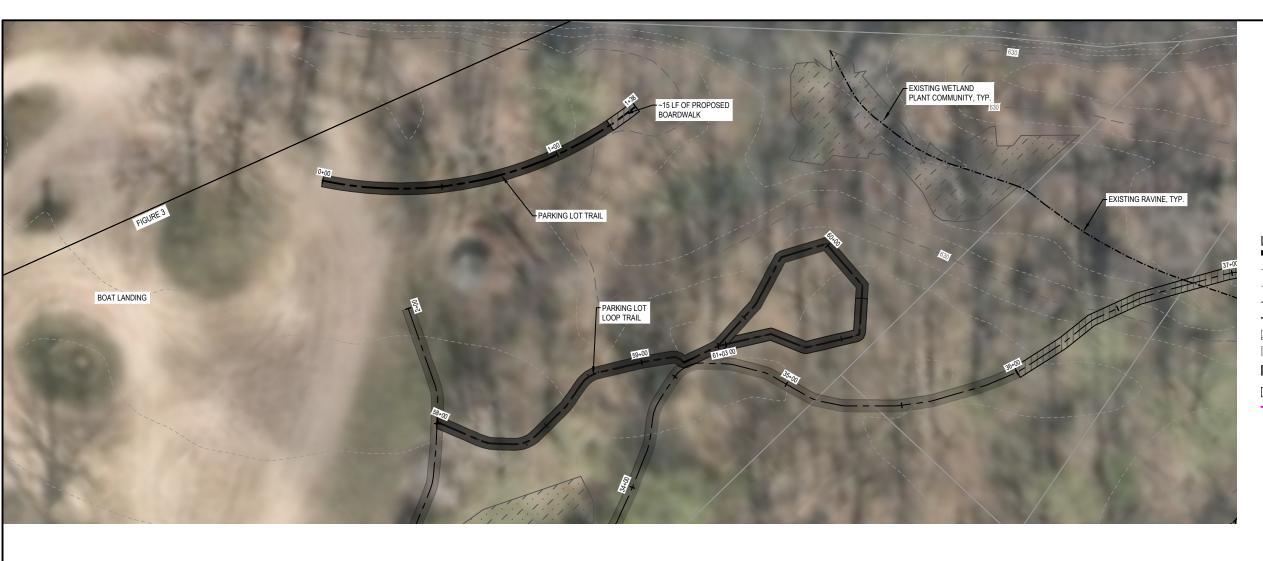
FIGURE 2

SHEET TITLE: MASTERPLAN TRAILS ANALYSIS (1 OF 4)
